# Manhole Inspection Summary

Manhole # S35II\_039MH

Insp Date: **3/12/07 1:52 PM**

**Location** Address: **1700 LANVALE ST**

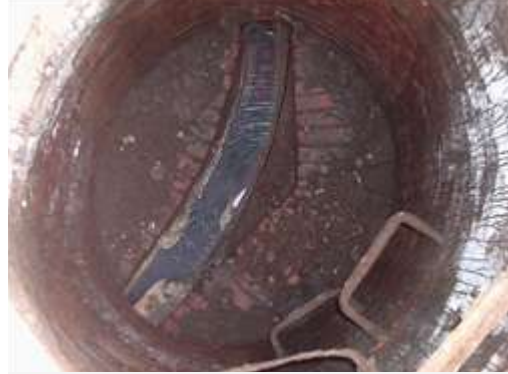
Top View

Corroded and missing steps. Evidence of surcharge - Bench debris. Channel debris.

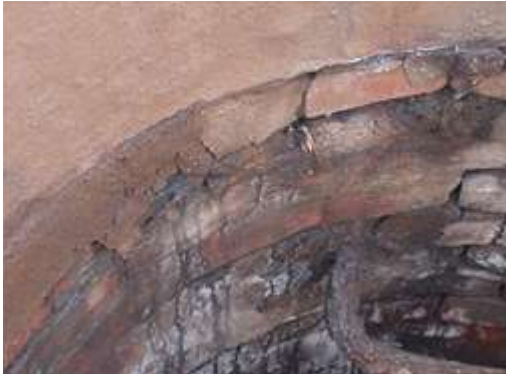
Defect

Frame leaks. Adjustment and Corbel deterioration and infiltration.

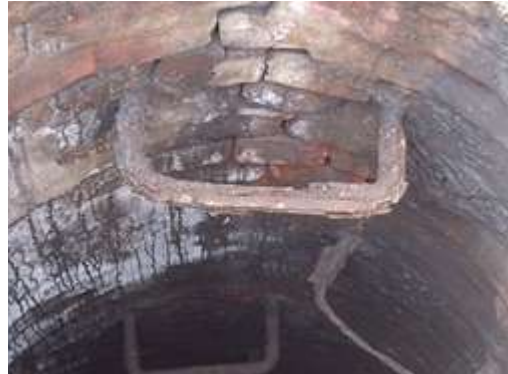
Defect

Corbel deterioration and infiltration. Barrel infiltration.

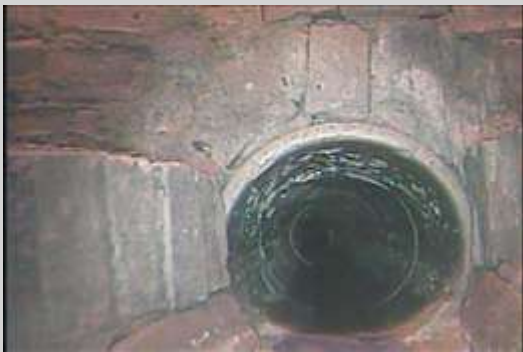
### 8 in. Circular Gravity Sewer Pipe Out @ 12 O'Clock

Deposits: ☐ None ☐ Mud ☐ Sludge ☐ Debris ☒ Grease

Silt Depth: **0** (in.) Deposits Extent: **Light**

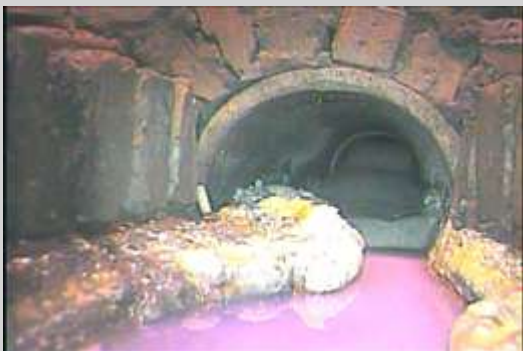
### 8 in. Circular Gravity Sewer Pipe In @ 7 O'Clock

Channel deterioration and root intrusion.

Deposits: ☐ None ☐ Mud ☐ Sludge ☒ Debris ☒ Grease

Silt Depth: **1** (in.) Deposits Extent: **Medium**

Infiltration: **None** Pipe Seal Cond: **Broken**
